SMILE Project - Studies on Irradiation Embrittlement and Irradiation Assisted Stress Corrosion Cracking of Core Support Structures and Internals

Abstract

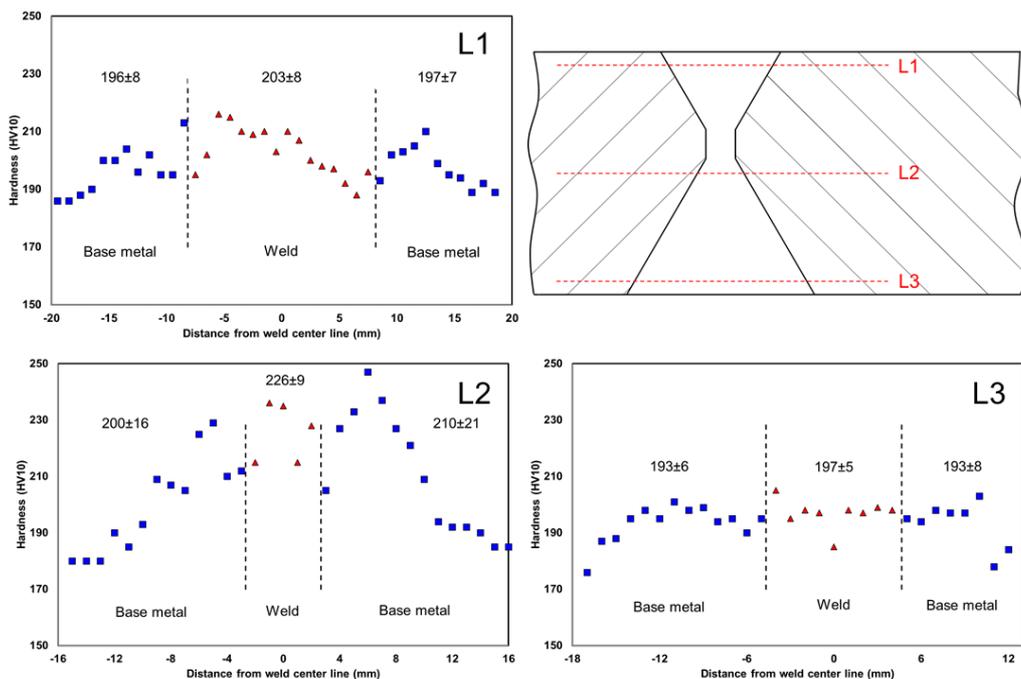
Information about the welds is available in reports from welding procedure qualification tests that were carried out and approved before welding of the core shroud took place. The plates used for the qualification tests were subjected to the same tests, examinations and treatments as the ones used for the upper cylindrical shell course, i.e., corrosion testing, ultrasonic testing, visual inspection, check of plate thickness, and dye penetrant testing of the edges prepared for welding. Following welding, all test welds were stress relieved at 400 °C (-0 °C, +50 °C) for 24 hours, after which they were subjected to radiographic testing and corrosion testing of specimens taken from three different locations in the thickness direction of the weld. All requirements of these tests and inspections performed before and after welding were fulfilled. The chemical composition of the weld (as-deposited) is shown in Table 2, while its mechanical properties are shown in Table 3. The ferrite content of the welds ranged from 9.0% to 10.6% with average and standard deviation values of 9.9% and 0.44%, respectively. Vickers hardness (HV10) measurements were made at three locations in the thickness direction of the weld; see Figure 3. These measurements showed that the hardness was quite uniform near the surfaces and that it was only slightly higher in the weld metal compared to the parent metal. A slightly higher variability in hardness of the weld along line 1 (L1) compared to line 3 (L3) is noted. At the centre of the weld and near the root pass, the hardness varied considerably, and the average was higher in the weld. However, peaks in hardness in the HAZ on either side of the weld were noted at all scanning locations.

Figure 3: Vickers hardness of the unirradiated welding procedure qualification test weld for the Oskarshamn 2 core shroud

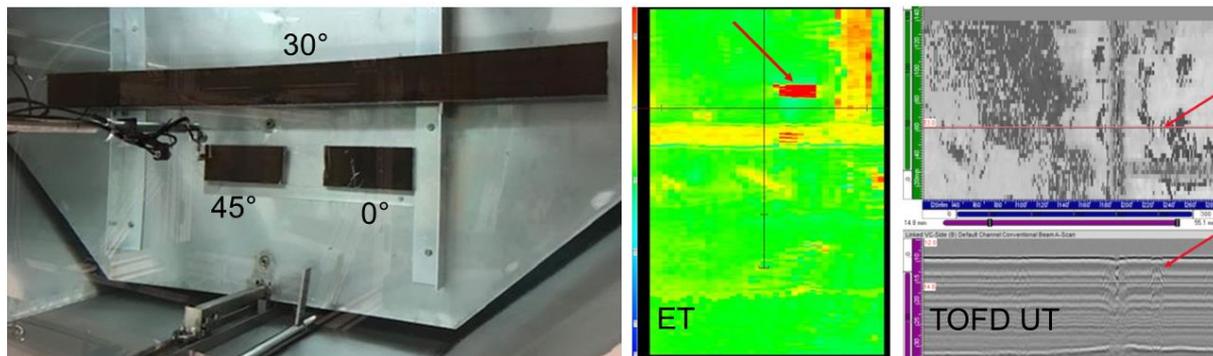
The three pieces cut from the core shroud were subjected to visual inspection, phased array ultrasonic testing (UT), time of flight diffraction (TOFD) testing, and eddy current testing (ET) in the pool facility at Studsvik. To the extent possible, eddy current and ultrasonic testing followed a procedure qualified for inspection of the intact Oskarshamn 2 core shroud at the reactor site. Deviations from the qualified procedure were the cut edges located relatively close to the weld that produced undesired signals, the longer manipulator arm holding the probes, and the manipulator arm only holding one probe at a time. In addition, ET scans were done on the inside as well as the outside surfaces of the pieces, while the qualified procedure only calls for inspection of one surface. Inspection by TOFD was done according to a best effort approach. No defects or indications of reportable size were observed in any of the pieces. However, when the detection threshold was lowered, one small (18 mm long and <0.5 mm) non-crack-like near-surface, or surface breaking, defect was noted by ET and TOFD (not UT) in the base metal of the piece cut at 0°. The defect was located rather close to the junction between the horizontal and vertical welds; see red arrows in Figure 5. Note that the defect was too small to have been considered for further analysis had it been detected during an in-service inspection campaign. Figure 5 shows the three pieces cut from the core shroud set up for inspection in the pool facility at Studsvik, and the ET and TOFD responses of the piece with the small defect. A metallographic sample will be prepared and examined to determine the nature of the defect.

Figure 5: Photograph of the three pieces cut from the core shroud, the manipulator arm holding the probes, and the inspection camera in the pool at Studsvik (left), ET (centre) and TOFD UT (right) responses of the piece located at 0°. The red arrows indicate the defect detected by ET and TOFD UT.

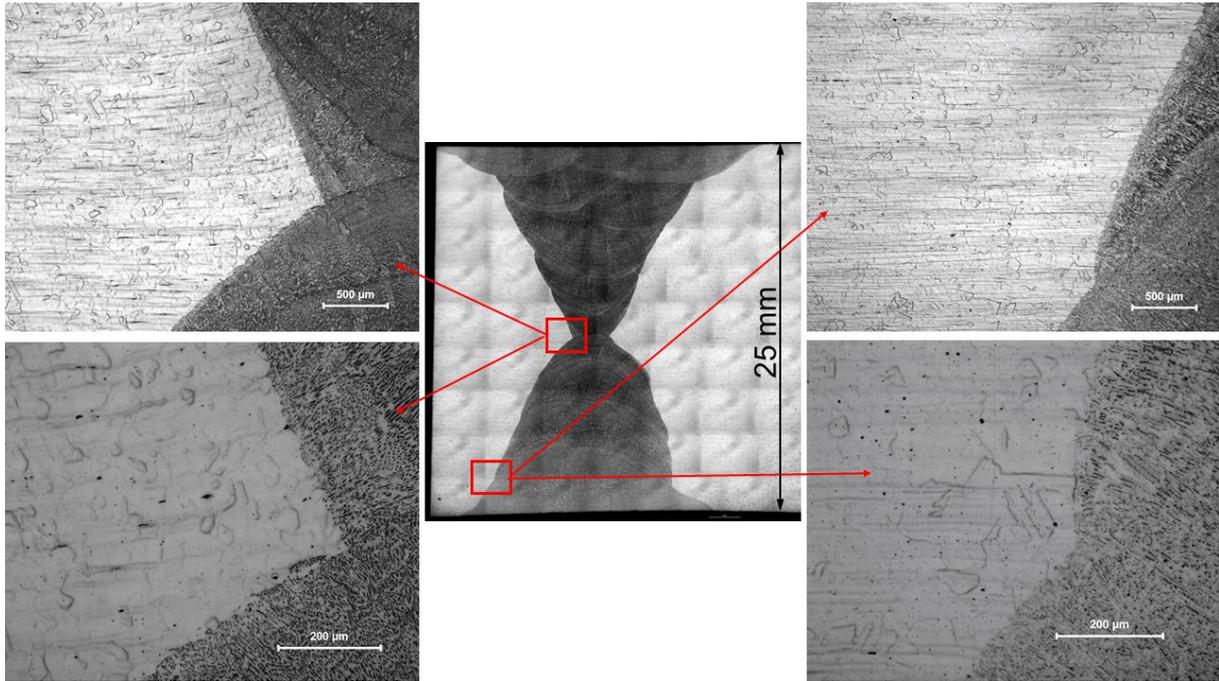
Micrographs of the sample located at 30° in the etched condition are presented in Figure 7. This figure covers the microstructure of the weld metal and the heat affected zone (HAZ). Figure 7 shows that the microstructures of the plate and weld were largely uniform and normal for stainless steel weld joints. The microstructure of the sample located at 0° was very similar, indicating the quality of the weld was uniform. Data from the micro hardness measurements are presented in Figure 8 with neutron dose estimates given in the figure caption. This figure shows that the hardness profiles were similar to the ones measured on the unirradiated welding procedure qualification test weld, i.e., the hardness was relatively uniform near the plate surfaces with a slightly higher hardness in the weld metal compared to the parent metal. Like the unirradiated test weld, the hardness at the centre of the weld and near the root pass varied considerably. The average hardness was higher in the weld, but peaks in hardness in the HAZ on either side of the weld were noted. A higher hardness was noted in the sample located at 30°, consistent with the higher neutron dose at this azimuth.

Figure 7: Microstructure of the horizontal core shroud weld in the piece located at 30°.

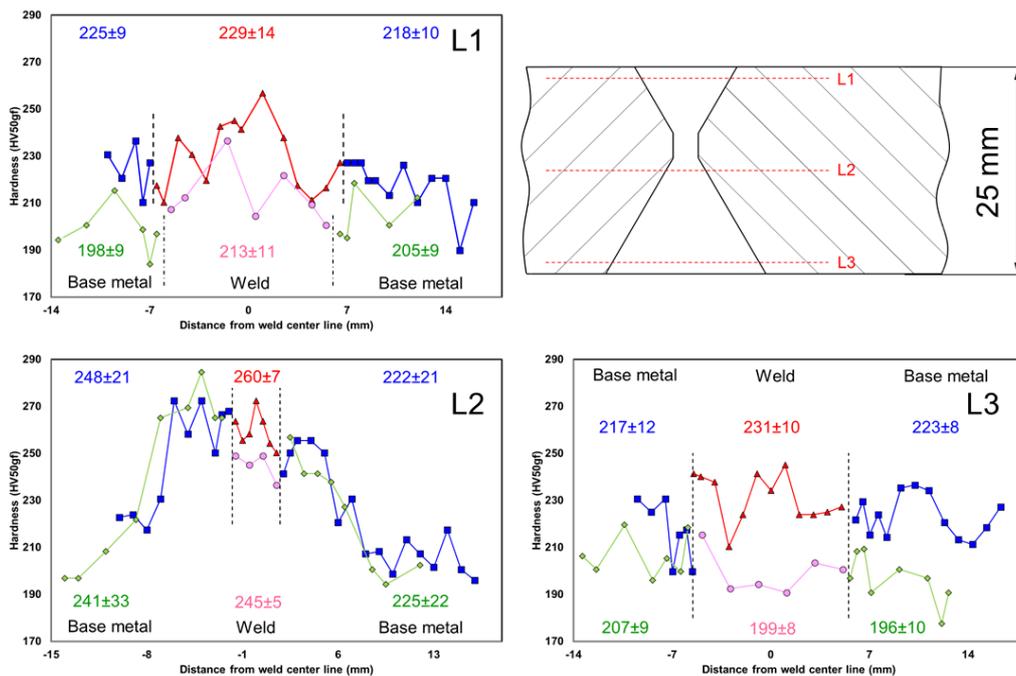
Figure 8: Vickers micro hardness (50 gf) of the horizontal core shroud weld at low (0°, ~0.05 dpa, green and pink data) and high dose (30°, ~0.5 dpa, blue and red data).
